The mundic problem

RICS guidance note, UK

3rd edition

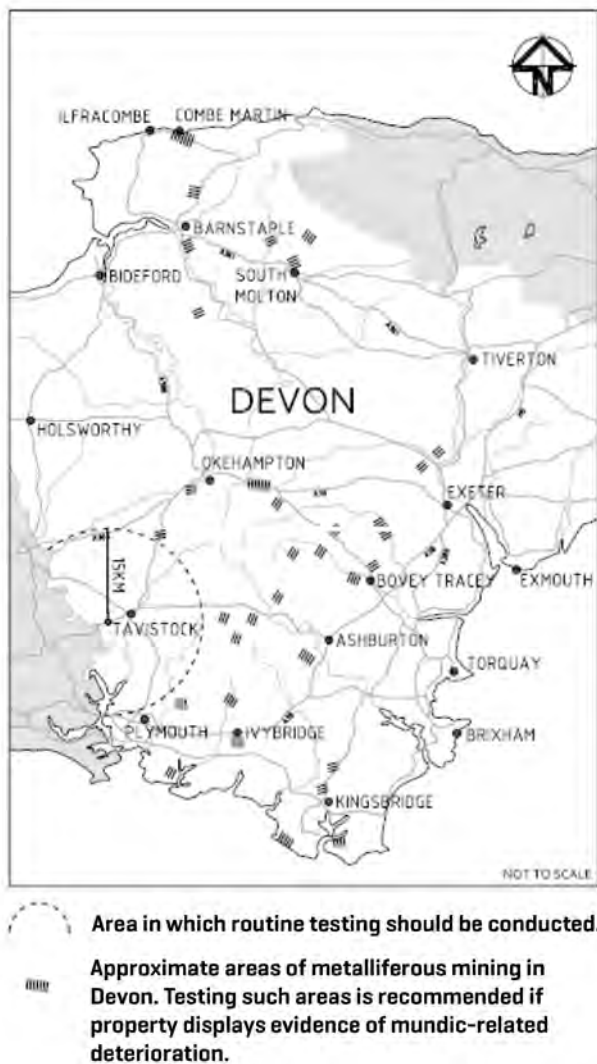
Figure 1: The dotted line on the map shows the approximate area of Devon where it is recommended routine testing be conducted. The dark bands indicate approximate areas of metalliferous mining in Devon; testing in and around such areas is recommended for properties displaying mundic-related deterioration

1.2.3 The areas of Devon in which mining wastes might have been used as concrete aggregate continue to be much more limited, therefore routine application of the guidance throughout Devon remains inappropriate. Areas in Devon where mining is known to have taken place are indicated on the map (Figure 1). Local practitioners should continue to exercise caution in these localities, and to use their local knowledge and established best practice to judge whether a test may be necessary (see section 1.6.2).

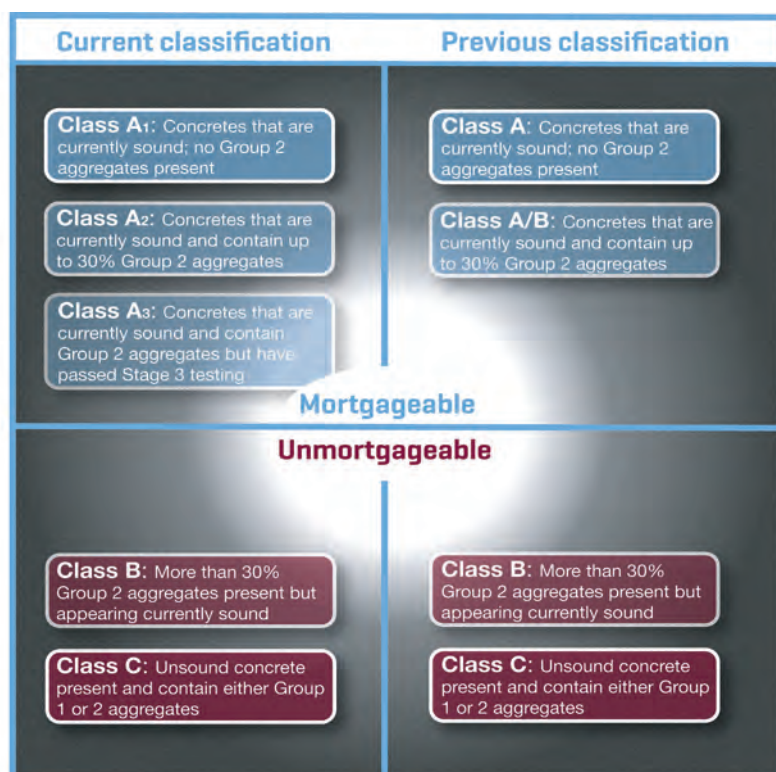
Figure 2: A comparison of previous and revised classifications of mundic concrete samples taken from walls (excluding mass concrete footings)

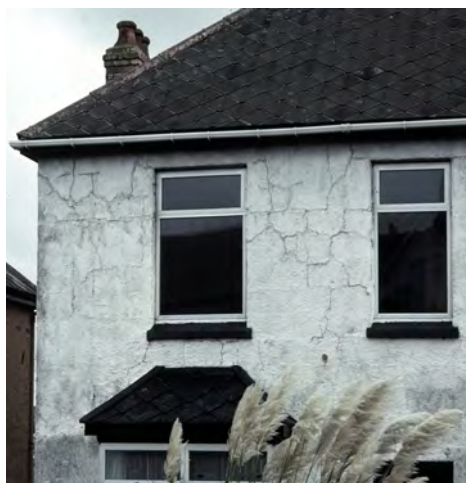
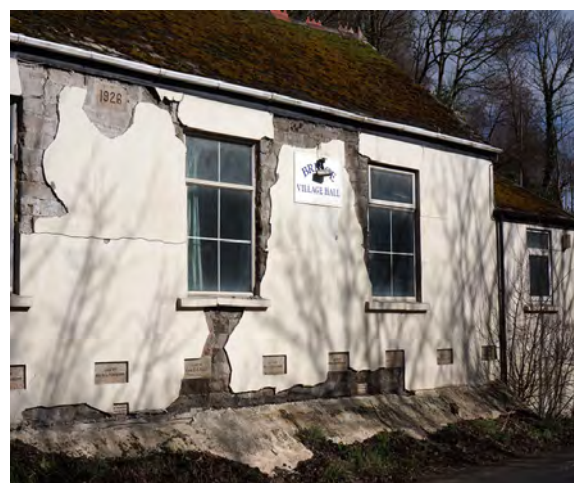
Figure 3: Photographs of two different properties exhibiting characteristic mundic damage

relevant limitations to the inspection, for example, weather conditions. Some examples of mundic-affected buildings are shown in Figure 3.

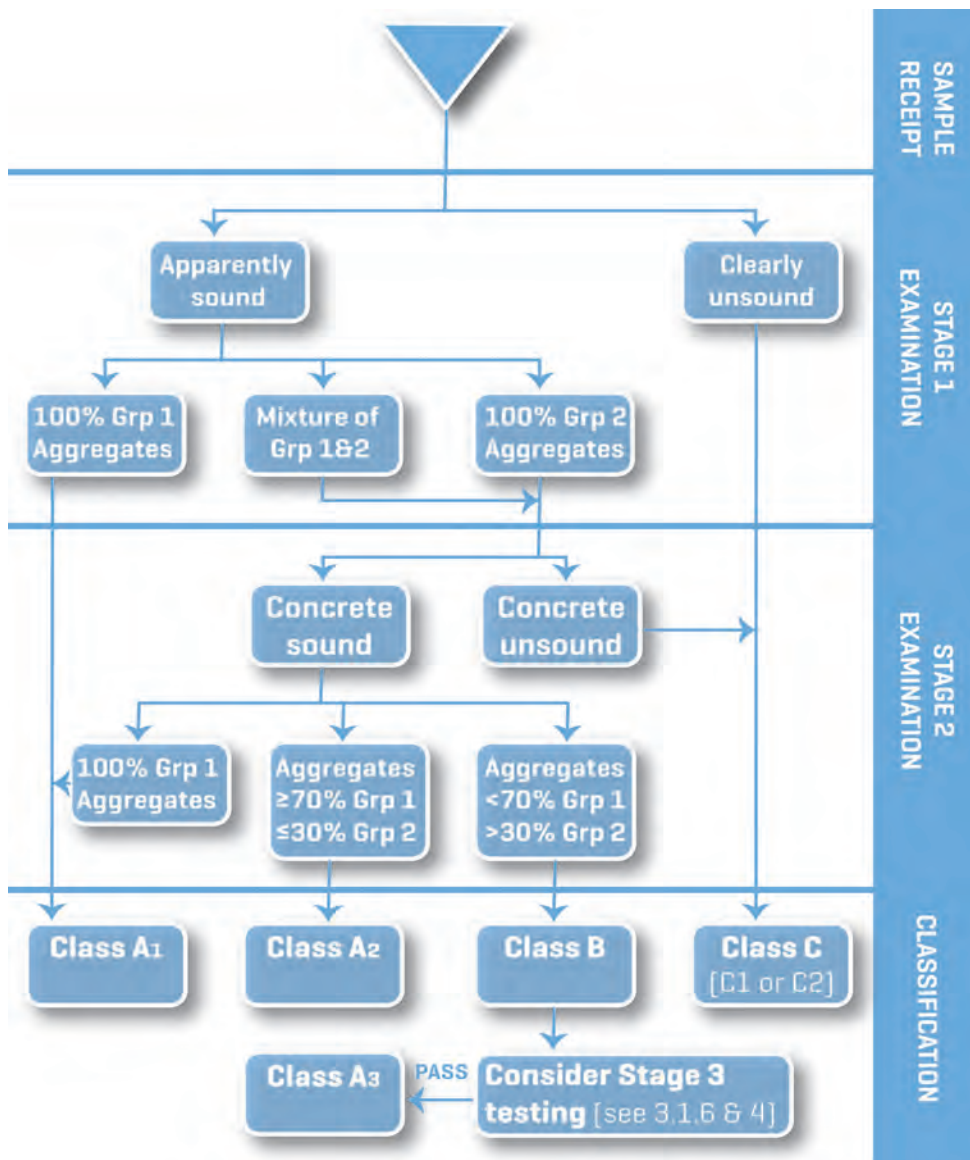
Figure 4: Examination and classification procedure

Note: The flow chart is simplified and reference should be made to the full text.

3.1.3 This section describes the progressive phases in the examination of concrete. There are two stages of examination and a third testing stage (see sections 3.1.6 and 4). Not all of these examination stages will be required for every sample, and it is emphasised that the progressive procedure described here will be concluded when a satisfactory classification of the concrete can be made. An outline of the typical investigation procedure using Stages 1 and 2 is shown in Figure 4, which also indicates the potential outcome of Stage 3, as detailed in section 4.

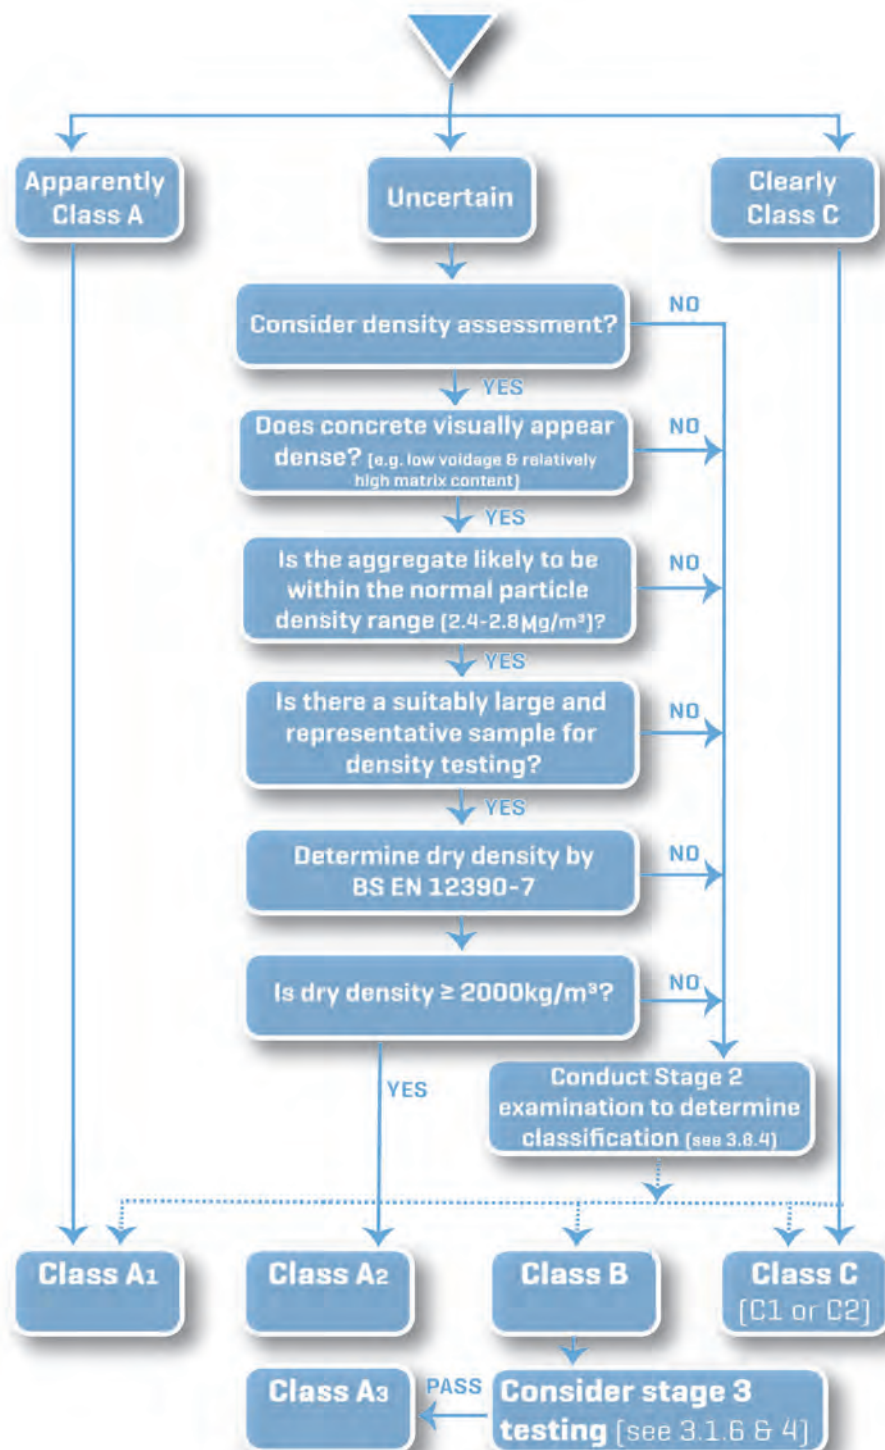
Figure 8: Flow chart showing special procedure for mass concrete footings

in accordance with BS EN 12390-7:2009.¹¹ This special procedure for mass concrete footings is outlined in Figure 8.

3.11.2 Samples exhibiting a dry density of 2000kg/m³ or more should be placed into Class A₂. Samples that do not appear dense and/or seem likely to contain either relatively heavyweight (say >2.8Mg/m³) or lightweight (say <2.4Mg/m³) aggregates, or tested samples exhibiting a dry density of less than 2000kg/m³ (unless reassessed as explained in sections 3.11.4 and 3.11.5), should be subjected to the Stage 2 examination procedure and classified accordingly (see sections 3.8 and especially 3.8.2).

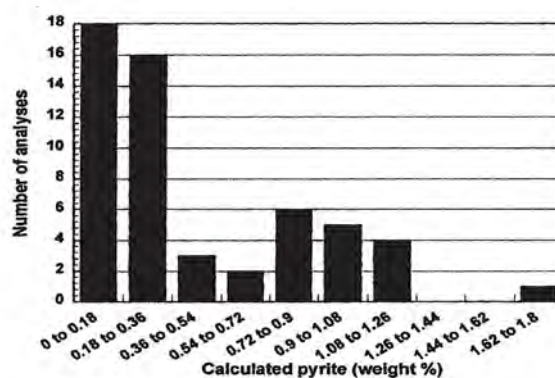
Figure D1: Calculated pyrite content in 54 concrete blocks made with Penlee aggregate

Figure D1 shows the calculated pyrite content of the analysed specimens. The data suggest that pyrite is bimodally distributed in the aggregate with maxima at approximately 0.15% and 0.8%. This may reflect gross variations in the disseminated pyrite content of the metadolerite. Alternatively, the high-pyrite aggregate may have been quarried from rock volumes that included sulphide-rich lode material emplaced into the metadolerite during the second stage of mineralisation.

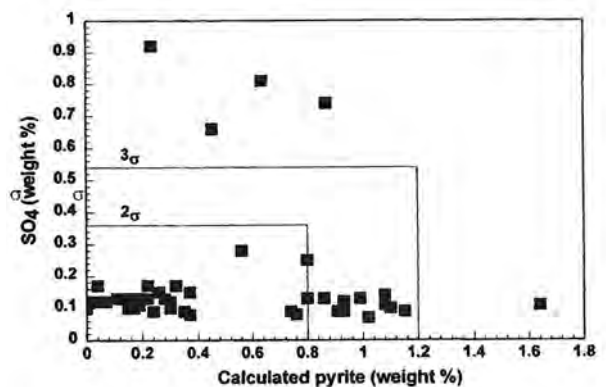
Figure D4: Plot of calculated Pyrite v. sulphate in 54 analysed samples of concrete made with Penlee aggregate. The boxes labelled 2σ and 3σ define compositions where pyrite and sulphate concentrations are less than 2σ and 3σ standard deviations respectively

Figure D4 is a plot of calculated pyrite v. sulphate (as SO₄). The boxes define regions in which calculated pyrite content and sulphate (as SO₄) are less than 2σ and 3σ respectively. The 2σ box encloses 37 (approx. 70%) of the analyses, including all of the low pyrite–low sulphate population. The 2σ pyrite line intersects the high pyrite population and its boundary might be lowered to about 0.6%. The 3σ box includes all but the specimen with highest pyrite content and four specimens with excess sulphate and which show clear evidence of in situ pyrite oxidation.

In concrete made with all-in Penlee metadolerite aggregate, one of the following safe limits might be advisable for sulphate and calculated pyrite concentrations:

- 0.6% pyrite and 0.4% sulphate (approx. 2σ). This is a very safe option but it would exclude many properties built with Penlee aggregate blocks in which there is no evidence of general concrete deterioration that might be ascribed to in situ pyrite oxidation.
- 1.2% pyrite and 0.6% sulphate (approx. 3σ). This would include many properties made with concrete having high pyrite concentrations but exclude the small number in which there is obvious evidence of sulphide-related concrete degradation.
