# Building Conservation Journal

## Behind the scenes

# Breathing space

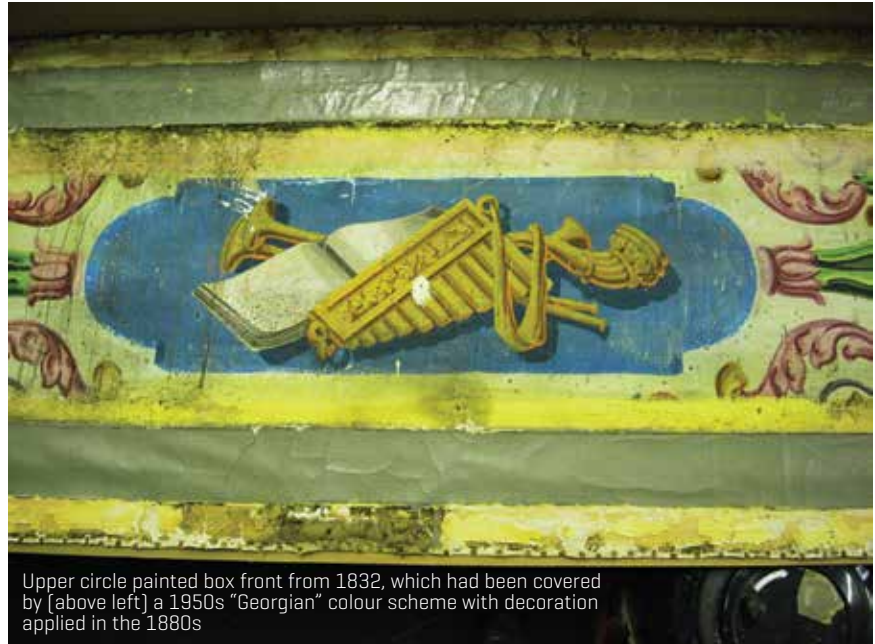
Upper circle painted box front from 1832, which had been covered by [above left] a 1950s "Georgian" colour scheme with decoration applied in the 1880s

2. The painted dress circle fronts of 1832 were supposed to be the sum total of the earliest decoration that survived. However, we were able to demonstrate that the remains of the 1766 interior decoration survived behind these painted canvas fronts.

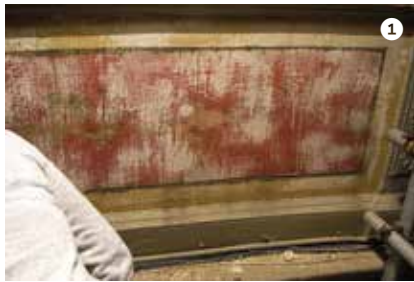
1 Upper circle box painted panelled front behind the 1832 facade

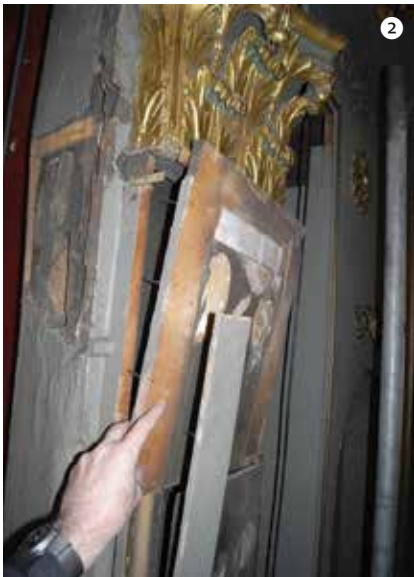
2 Corinthian capital carved in perspective, raised in 1880s (note the fluting below hand)

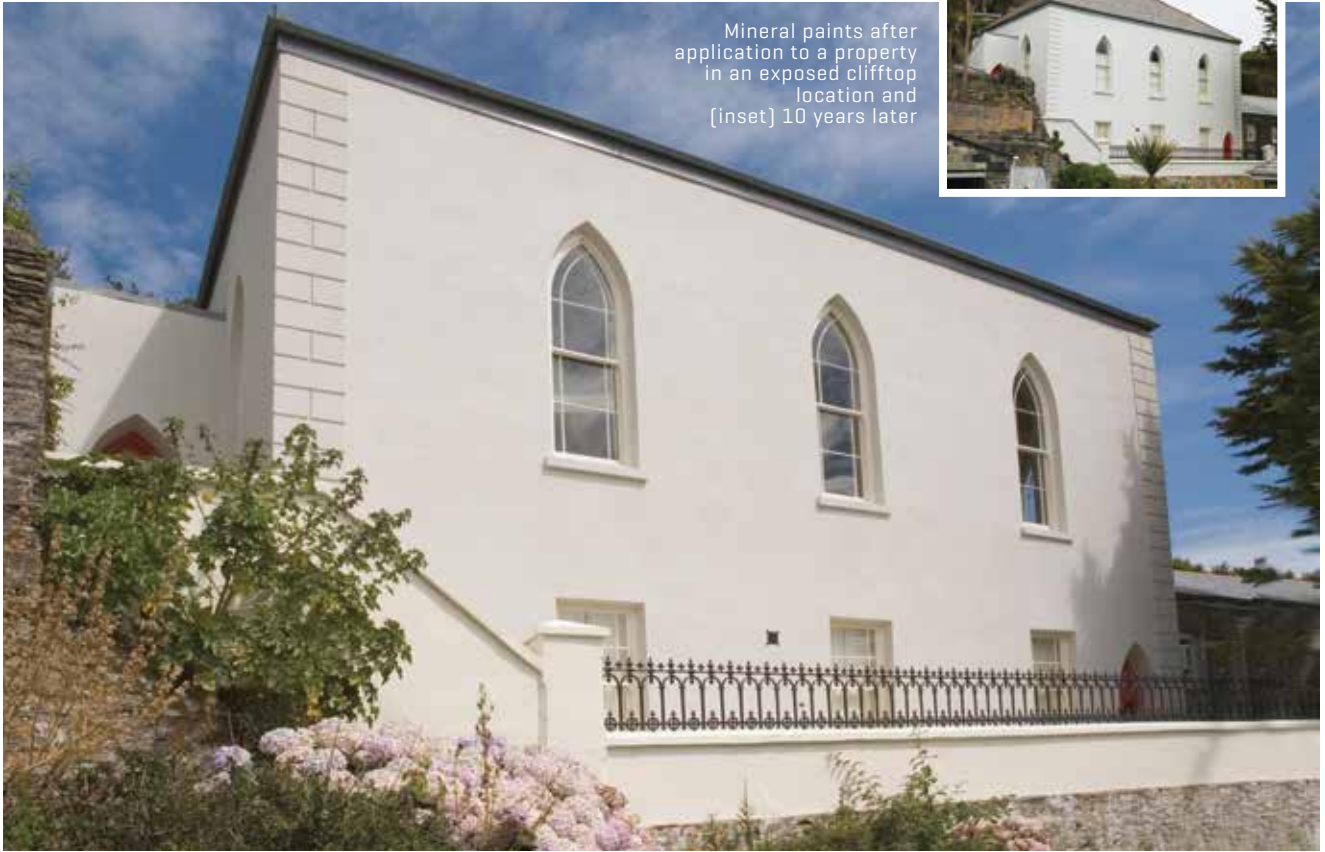
Mineral paints after application to a property in an exposed clifftop location and [inset] 10 years later

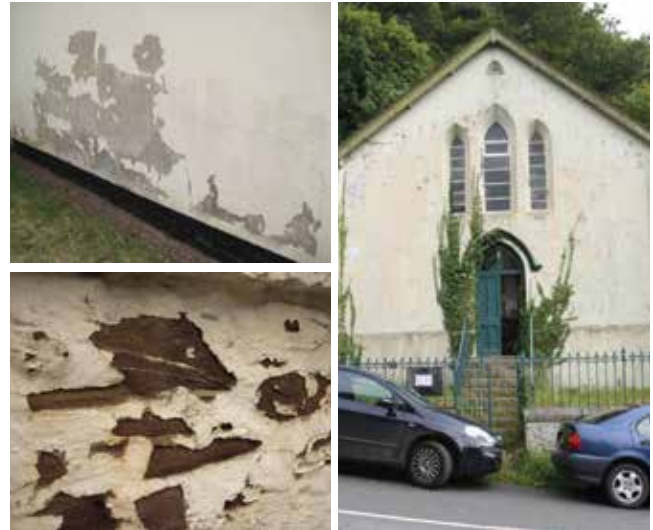
Hydraulic pressure in action

A build-up of moisture can cause blistering and bubbling of the paint where the water is trying to escape (see image, above right) and is referred to as hydraulic pressure. In more serious cases, the render may be blown – that is, forced off by the pressure of the trapped water. If accumulated water does not blow the coating, it can transfer internally, leading to issues such as damp.
