## Cavity Wall Defects

### Cutting through the current mass hysteria

Presented By: Joe Malone BSC(Hons) MCIQB C. Build.E MCABE

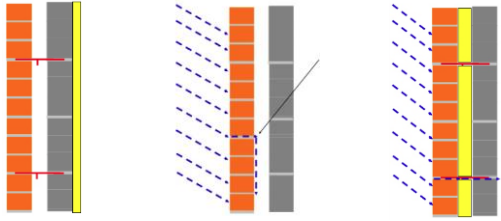
The cavity is primarily to prevent moisture transfer To the inner leaf!

Moisture break      Penetration can drain      Problems caused by full fill!

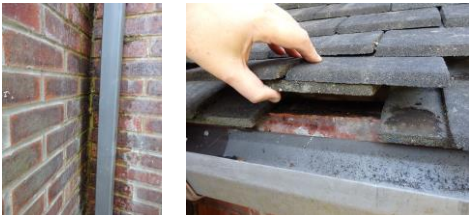
**What about blown Polystyrene bead CWI?**

- We recently inspected a cavity walled property in Staffordshire with significant penetrating damp. The property had polystyrene beads installed to the wall cavity.
- The cavity was inspected with an electronic borescope due to a significant problem with penetrating damp on the inner face of the lounge wall. This revealed the cavity was fully filled with polystyrene beads. Even visually these appeared to be wet.

Saturated masonry and lack of sarking into gutter or eaves flashing

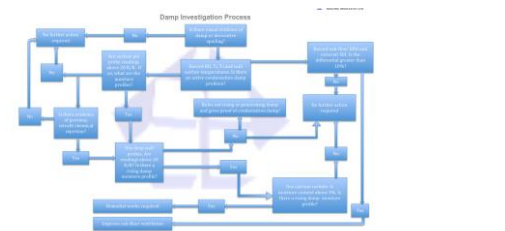
**The Damp Investigation Process Should be consistent!**

The flowchart illustrates a systematic approach to damp investigation, starting with 'Visual Inspection' and 'External Inspection', leading to 'Internal Inspection', 'Damp Investigation Process', and finally 'Damp Investigation Report'.

- This does not in itself mean that CWI is to blame
- Ensure you have fully investigated the external defects and understand the initial cause of moisture
- You can carry out an ERH test to assess levels of interstitial humidity and condensation.
- Ensure you take a benchmark reading for ambient humidity!
- Inspect the cavity using a Portascope or electronic borescope
- Remember if CWI is installed then you'll see very little and the wall may need opening up for inspection.
- If you open up the wall, the chances are that you'll find perfectly dry blown fibre CWI
- Remember that if you open up a wall containing polystyrene beads then you may lose a lot of material.
- If blown fibre is installed, feel the bottom of the cavity, is there any wet slumped material?
